# Manhole Inspection Summary

Manhole # S1100\_016MH

Insp Date: **8/13/07 2:03 PM**

**Location** Address: **2503 ELLAMONT AVE**

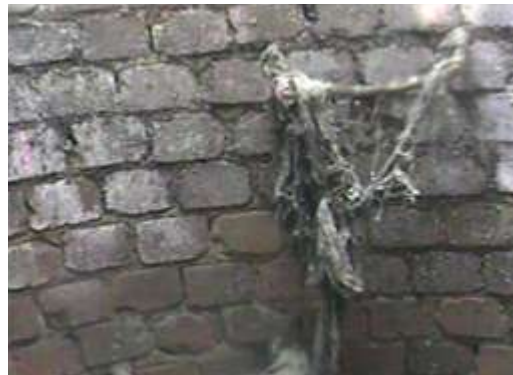
Defect 1

**Steps** Count: **5** Missing: **0** ☒ **Corroded**

**Surcharge** ☒ **Evidence Of Surcharge** Depth: **8** (ft.) ☐ Active Surcharge Present

SURCHARGE EVIDENCE AND  
CORRODED STEP

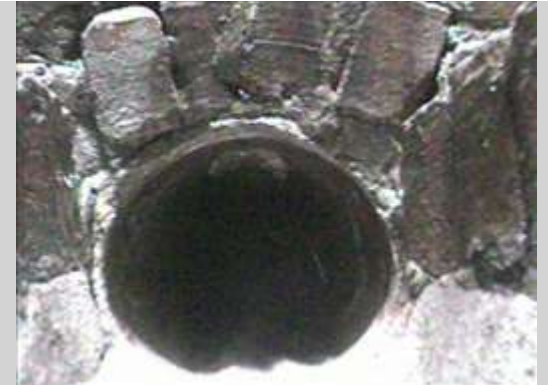
12 O'Clock Outflow

8 in. Circular Gravity Sewer  
Pipe Out @ 12 O'Clock

Pipe Material: **Clay** ☐ Pipe Lined

Invert Depth: **10.38** (ft.) Flow Characteristics: **Fast**

Deposits: ☒ None ☐ Mud ☐ Sludge ☐ Debris ☐ Grease

Infiltration: **None** Pipe Seal Cond: **Sound**

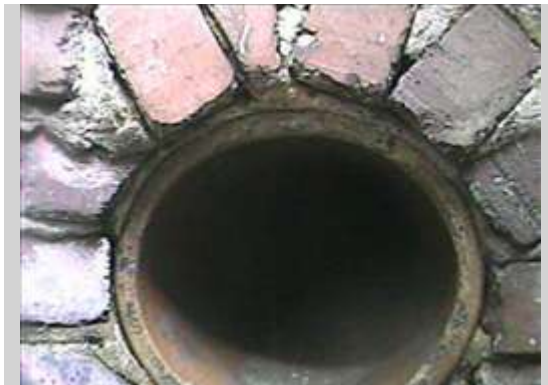
6 O'Clock Inflow

8 in. Circular Gravity Sewer  
Pipe In @ 6 O'Clock

Pipe Material: **Clay** ☐ Pipe Lined

Invert Depth: **4.20** (ft.) Flow Characteristics: **Fast**

Deposits: ☒ None ☐ Mud ☐ Sludge ☐ Debris ☐ Grease

Infiltration: **None** Pipe Seal Cond: **Sound**

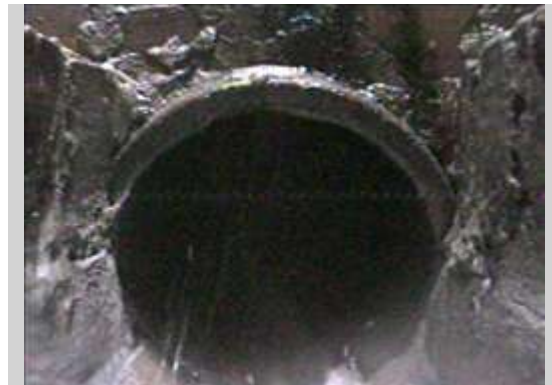
Drop In @ 6 O'Clock

Drop: **Outside Direct**

Inv Depth: **10.29** (ft.)

Drop Condition: **Open**
